Lac-Mégantic runaway train and deralement investigation summary

This summary of the Transportation Safety Board of Canada's (TSB) Railway Investigation Report R13D0054 contains a description of the accident, along with an overview of the analysis and findings, the safety action taken to date, five key recommendations, and what more needs to be done to help ensure an accident like this does not happen again.

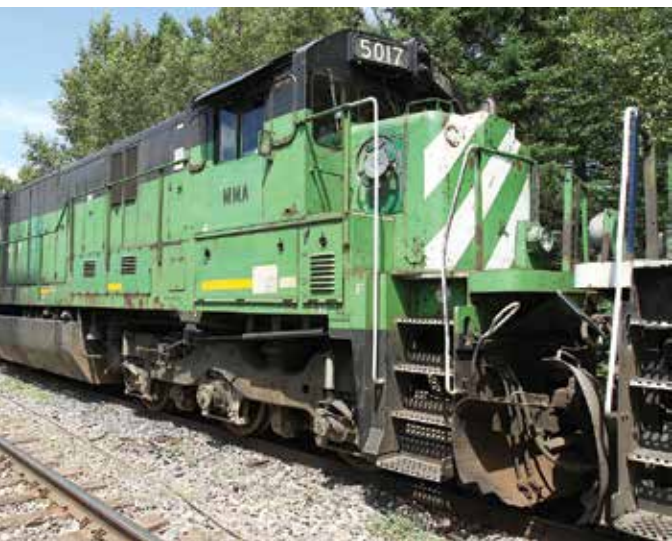
Fire in the locomotive

In October 2012, eight months before this accident, the lead locomotive was sent to MMA's repair shop following an engine failure. Given the significant time and cost of a standard repair, and the pressure to return the locomotive to service, the engine was repaired with an epoxy-like material that lacked the required strength and durability. This material failed in service, leading to engine surges and excessive black and white smoke. Eventually, oil began to accumulate in the body of the turbocharger, where it overheated and caught fire on the night of the accident.

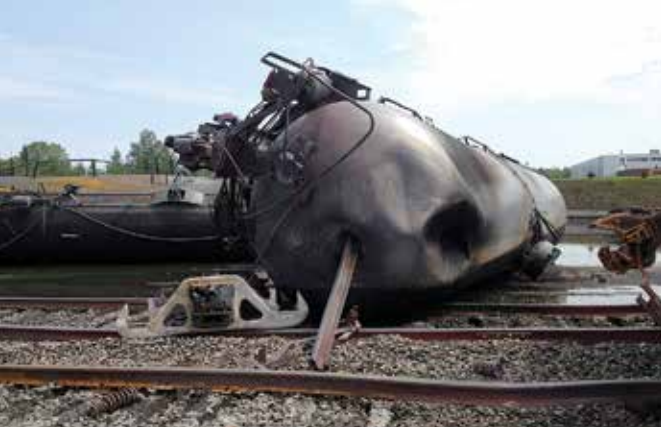
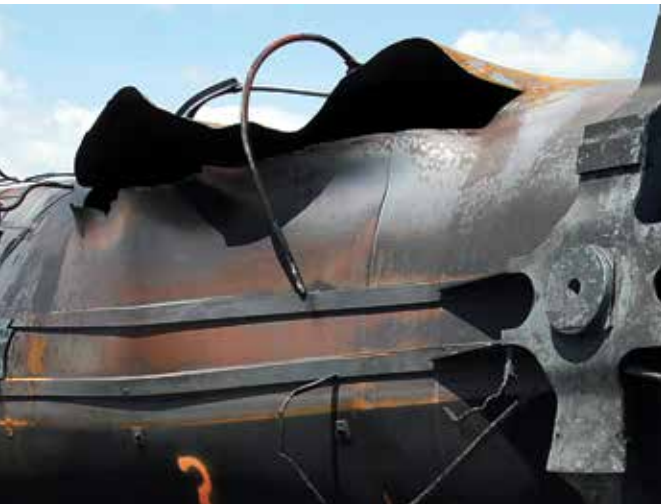
Class 111 tank cars: Damage and construction

All 72 tanks cars were Class 111, manufactured between 1980 and 2012. Although they met requirements in effect at the time, they were built to an older standard, and they lacked enhancements such as a jacket, a full head shield, and thermal protection.

Almost every car that derailed was breached, some in multiple areas, including shells, heads, top and bottom fittings, and pressure relief devices. The exact location and extent of the damage varied depending on the orientation and speed of the cars during the derailment.

When the tank cars were breached, the petroleum crude oil was released, fuelling the fire. The damage to the tank cars could have been reduced by enhanced safety features. This is why the TSB called for tougher standards for tank cars carrying flammable liquids.
