Lac-Mégantic runaway train and deralement investigation summary

This summary of the Transportation Safety Board of Canada's (TSB) Railway Investigation Report R13D0054 contains a description of the accident, along with an overview of the analysis and findings, the safety action taken to date, five key recommendations, and what more needs to be done to help ensure an accident like this does not happen again.

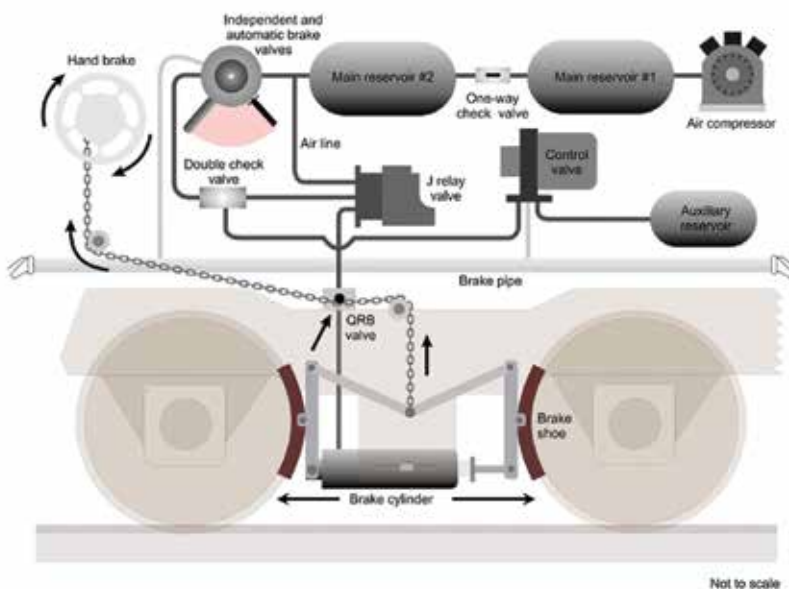
In addition to air brake systems, all locomotives and rail cars are equipped with at least one hand brake. This is a mechanical device that applies brake shoes to the wheels to prevent them from moving.

The effectiveness of hand brakes depends on several factors, including their age, their maintained condition, their application in conjunction with air brakes, and the force exerted by the person applying the hand brake, which can vary widely.

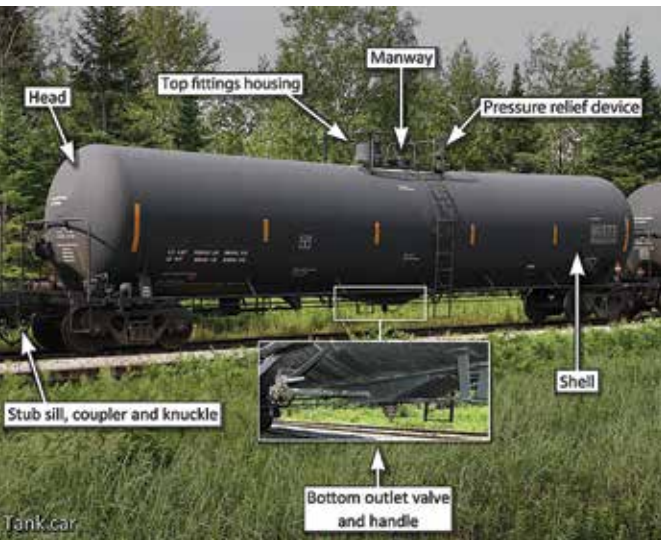
Almost every car that derailed was breached, some in multiple areas, including shells, heads, top and bottom fittings, and pressure relief devices. The exact location and extent of the damage varied depending on the orientation and speed of the cars during the derailment.

When the tank cars were breached, the petroleum crude oil was released, fuelling the fire. The damage to the tank cars could have been reduced by enhanced safety features. This is why the TSB called for tougher standards for tank cars carrying flammable liquids.
